NASA/TM-2009-215572
NESC-RP-06-49/06-001-E

International Space Station (ISS) External Television (TV) Camera Shutdown Investigation

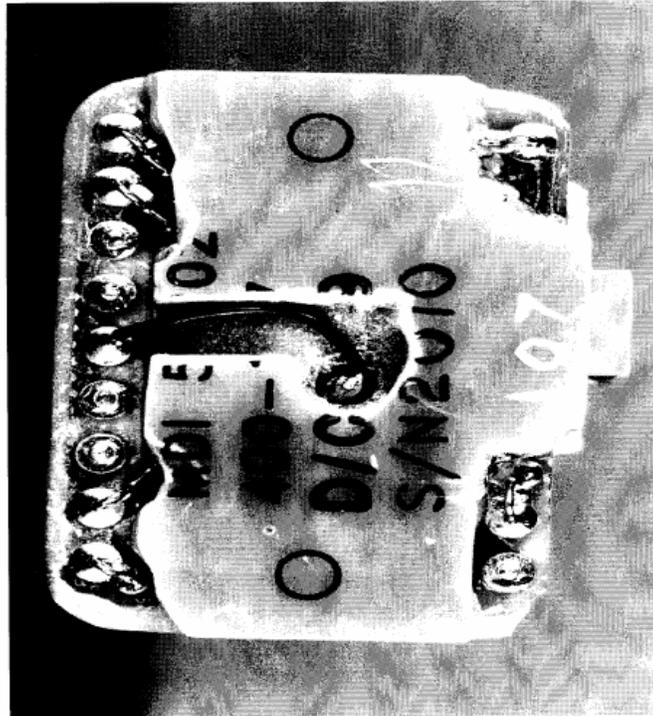
Figure 7.4-1. Picture of Reworked Power Supply showing Leash/Jumper Wires
[ref. Heydman, William, "AOE 0473, TRC Power Supply Card Out of Spec", Current ECD
dated 22 September 1999]

3. Fractured solder joints on swaged terminals due to poor printed wiring board (PWB) design/layout. Swaged terminals installed in un-plated through holes, insufficient solder, and dissimilar materials.

4. Fractured solder joints on transformer pins due to poor PWB design/layout, installation in un-plated through holes, poor solder wetting, and dissimilar materials.

10. Rework of transformer caused cracks in 2oz. and 4oz. copper traces. Leash repair of all pins and terminals completed (see Figures 7.4-1 & 7.4-2).
11. Extensive rework performed to correct these problems (at least 2,530 repairs, added wires, reworks, and touch-ups).

ring/pad at the top and far side of the board. On many of the connections, the terminal was used as the connection from a top-side circuit trace to a back-side trace. This means if either the top or far side solder joint cracked, it could result in an intermittent connection. There are over 100 solder terminals in each MDI power supply. L-3 Communications ended up doing a full replacement of each wire in the harness and soldered a bus wire “leash” from each terminal to a lap solder joint on each related trace.
